Hazardous Materials Accident Report

Hazardous Materials Release From Railroad Tank Car With Subsequent Fire at Riverview, Michigan July 14, 2001

**National
Transportation
Safety Board**
Washington, D.C.

**NTSB/HZM-02/01
PB2002-917002
Notation 7400A
Adopted June 26, 2002**

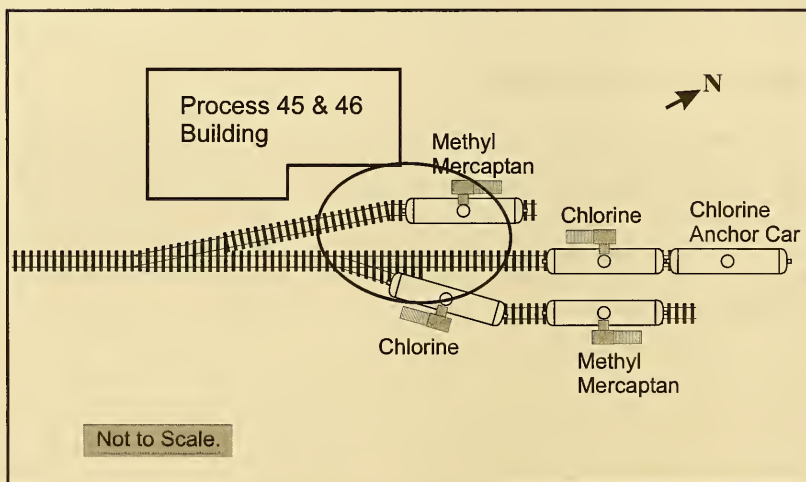
Figure 2. Accident site. (The circled area is the area of greatest fire damage.)

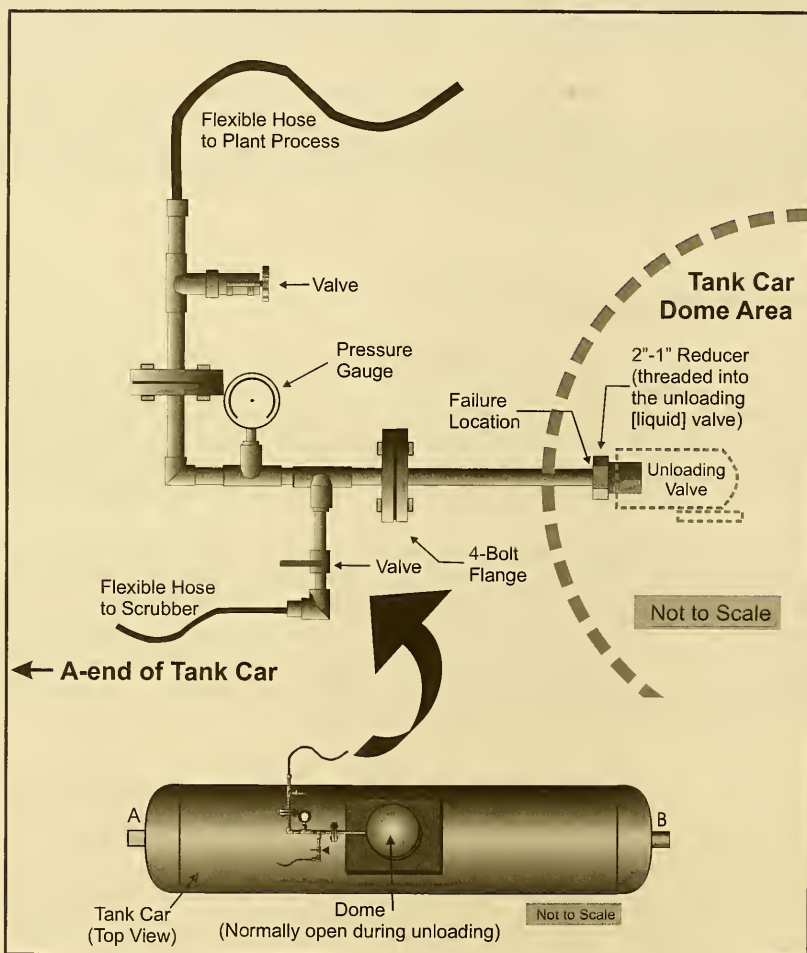
Figure 4. Overhead view of unloading apparatus. (For clarity, the pressure gauge, valves, and scrubber line have been rotated into the horizontal plane.)

As noted earlier, a 1-inch-diameter steel pipe in the unloading apparatus of UTLX 900558 was separated at the point the pipe threads exited a 2- to 1-inch reducer installed in the tank car's unloading valve. The flexible hoses attached to the unloading apparatus on both tank cars were melted and partially consumed by the fire.

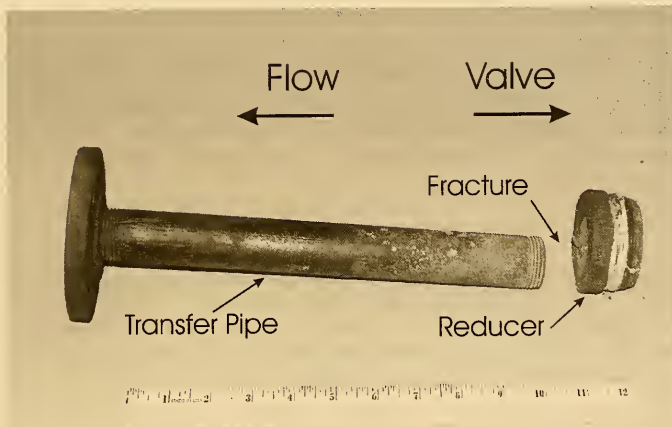
Figure 5. Separated transfer pipe.

The Safety Board's metallurgical examination of the separated steel pipe in the unloading apparatus (figure 5) did not identify any evidence of preexisting cracks on the fracture surface; the fracture features were typical of an overstress separation. Examination of the pipe revealed evidence of corrosion, including deposits of iron oxide (rust) and pitting on both interior and exterior surfaces. (The interior surfaces of the pipe were exposed to the weather whenever the unloading apparatus was not in place on a tank car.)

Measurements of the interior and exterior diameters at several locations on the length of the pipe were compared with interior and exterior diameters for new pipe. These comparisons revealed that the outside diameter was comparatively the same as that of new pipe; however, the inside diameter near the end of the pipe where the failure occurred showed evidence of erosion-corrosion damage (discussed in the next section) that reduced the wall thickness near the fracture by about 23 percent as compared to the inside diameter of new pipe.

Calculations made using the weight of each of the unloading apparatus components, their distances from the pipe separation, the standard (as manufactured) wall thickness of 1-inch pipe, and standard piping design and engineering formulas indicate that bending stresses on a new pipe at the point the pipe entered the reducer would have been 20,800 pounds per square inch (psi). The wall thickness reduction of the accident pipe that resulted from erosion-corrosion resulted in a 20-percent increase in the calculated bending stress on the pipe, to 25,100 psi at the point of fracture. Comparing the bending stress to the strength of the material, Safety Board metallurgists estimated that an additional force of about 175 pounds (added to the existing force represented by the weight of the unloading apparatus), if applied at the outer end of the unloading apparatus, would cause an overstress failure (fracture) of the pipe.
